magicolor[®] 330

Service Manual

November 2000
1750049-001B

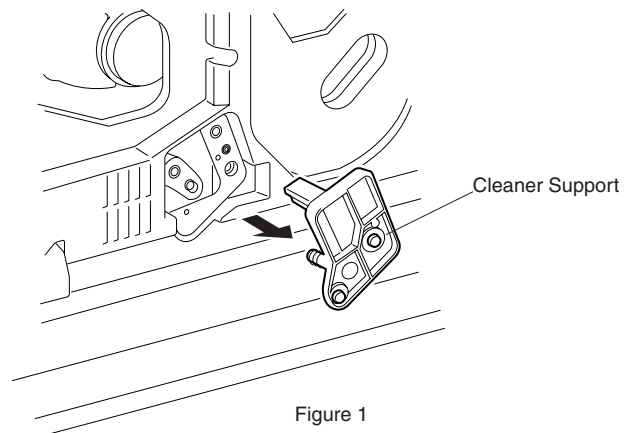
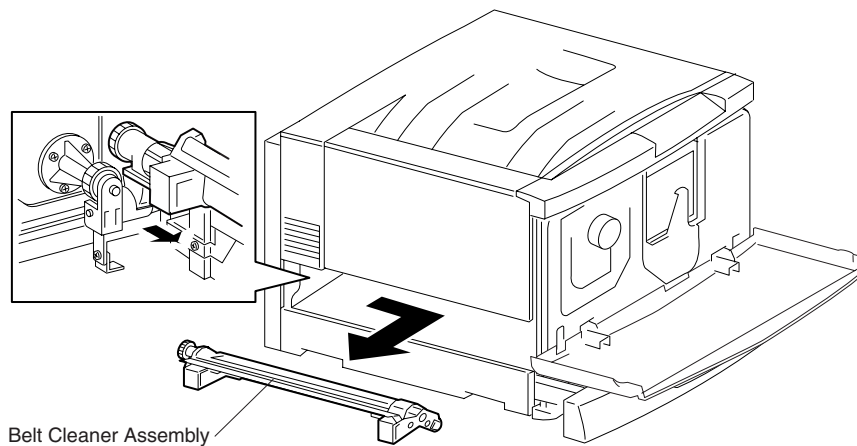
RS1071XB

RRP 9.76 Belt Cleaner Assembly (PL8.1.30)

1. Remove the Fuser Assembly (RRP 9.80).
2. Open the Front Cover.
3. Reach in through the empty Fuser Assembly cavity and hold the bottom of the Belt Cleaner Assembly.
4. Loosen the two screws securing the Cleaner Support to the printer frame and remove the Cleaner Support (Figure 1).
5. Slide the Belt Cleaner Assembly to the front of the printer and remove the Assembly through the Fuser cavity (Figure 2).

1. Reinstall the Belt Cleaner Assembly through the empty Fuser cavity.
2. Line up the mark on positioning pin at the rear of the Assembly with the mark on the positioning hole at the rear of the printer and slide the pin into the hole.
3. Line up the two screws attached to the Cleaner Support with the screw holes in the printer frame.
4. Line up the front of the Belt Cleaner Assembly with the spring and support bar sticking out from the Cleaner Support.
5. Tighten the two screws attached to the Cleaner Support to secure the Support and the Belt Cleaner Assembly to the printer frame.
6. Reach in through the Fuser cavity and raise and release the Belt Cleaner Assembly to make sure the Assembly moves freely.
7. Reinstall the Fuser Assembly (RRP 9.80).
8. Refer to Section 9 of this manual and reset the Belt Cleaner Assembly Life Counter to zero.

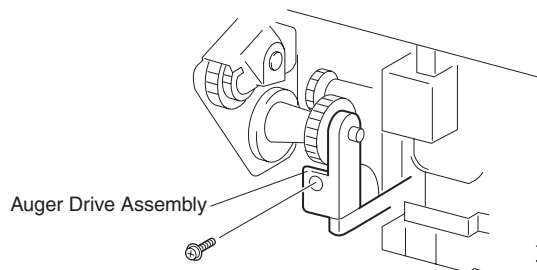
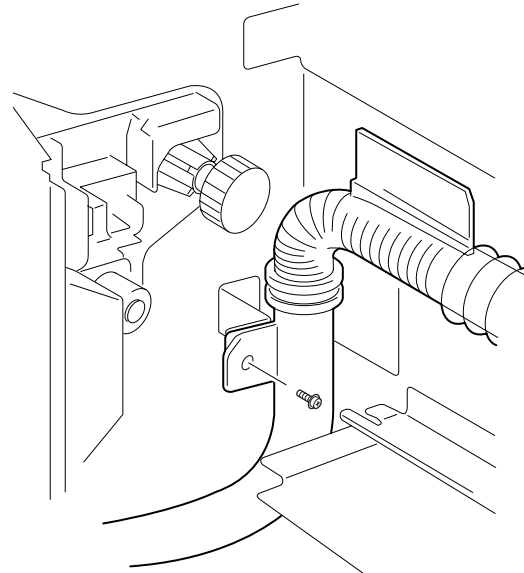
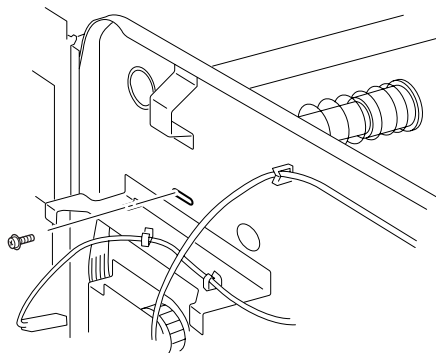
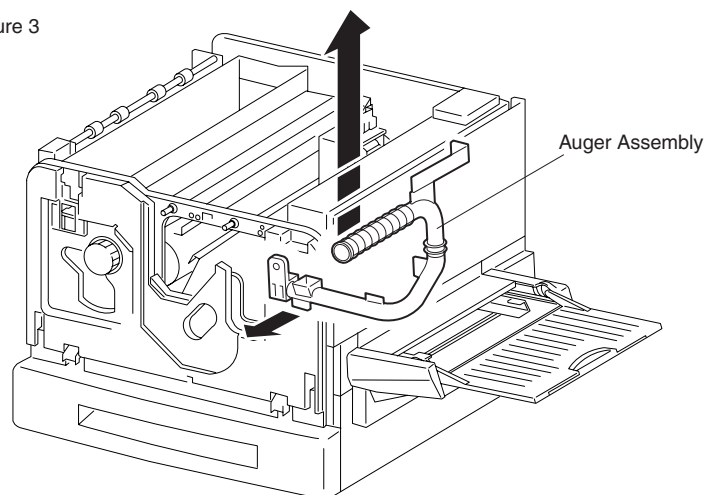
RS1072XB

RRP 9.77 Auger Assembly (PL8.1.40)

1. Remove the Transfer Assembly (RRP 9.71).
2. Remove 2nd BTR Assembly (RRP 9.75).
3. Remove the Fuser Drive Assembly (RRP 9.110).
4. Remove the two screws securing the IBT Rear Bracket to the rear of the printer frame and remove the Bracket.
5. Remove the screw securing the Auger Drive Assembly to the printer frame (Figure 1).
6. Remove the screw securing the Auger Tube to the rear of the printer frame (Figure 2).
7. Remove the screw securing the Auger Assembly bracket to the rear of the printer frame (Figure 3).
8. Swing the bottom of the Auger Assembly out, then slide the Auger Assembly down and remove the Assembly from the printer (Figure 4).

1. Reinstall the Auger Assembly onto the printer (Figure 4).
2. Slide the Auger Assembly bracket into position at the rear of the printer frame and use one screw to secure the bracket.
3. Use one screw to secure the Auger Tube to the rear of the printer frame.
4. Use one screw to secure the Auger Drive Assembly to the printer frame.
5. Reinstall the IBT Rear Bracket to the rear of the printer frame and use two screws to secure the Bracket.
6. Reinstall the Fuser Drive Assembly (RRP 9.110).
7. Reinstall the 2nd BTR Assembly (RRP 9.75).
8. Reinstall the Transfer Assembly (RRP 9.71).

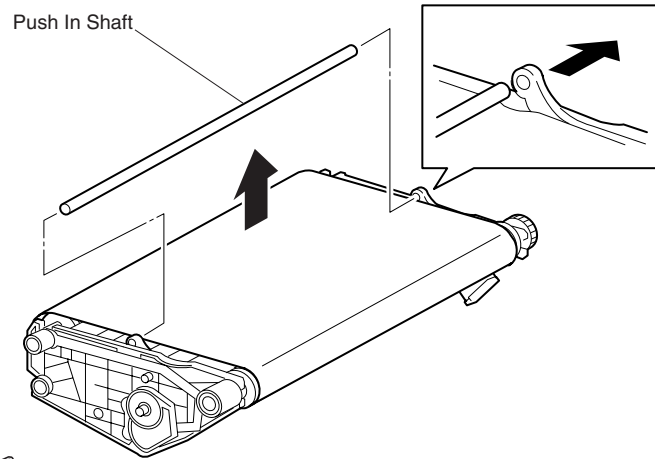
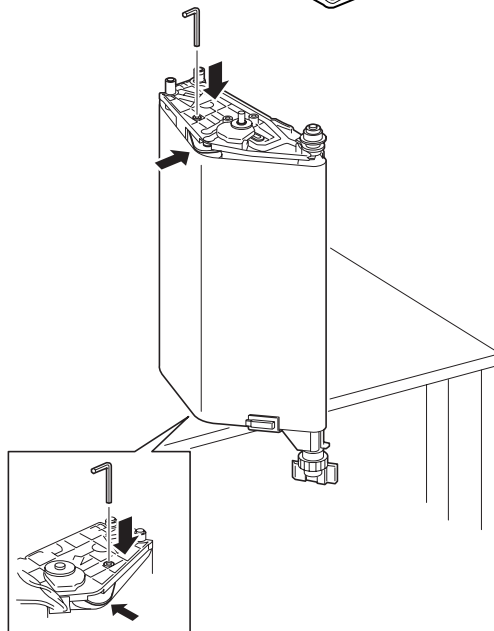
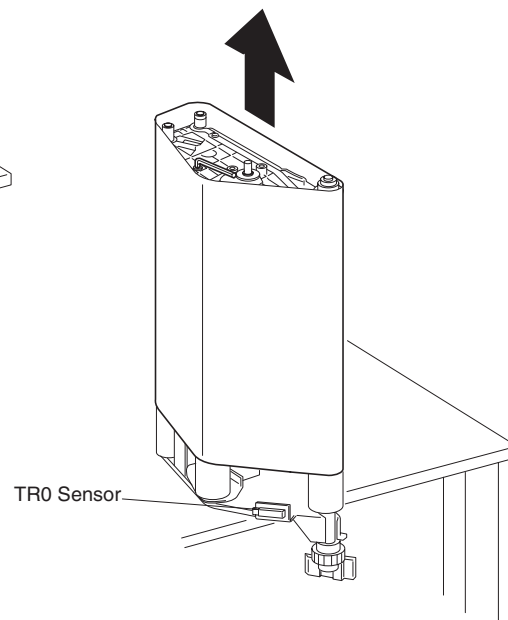
RS1073XB

RRP 9.78 IBT Belt Assembly (PL8.2.2)

1. Position the IBT Belt Assembly so that when the Belt is reinstalled onto the Transfer Assembly, the two edge marks are on the same side as the TR0 Sensor.
2. Carefully rotate and slide the Belt onto the Transfer Assembly.
3. Continue sliding the Belt onto the Transfer Assembly until the edge marks are under the TR0 Sensor.
4. Remove the two long screws or allen wrenches that are locking the Middle Drive Roll in place.
5. Raise the Shaft arms above the Belt and reinstall the Push In Shaft into the ends of the Shaft arms.
6. Reinstall the Transfer Assembly (RRP 9.71).

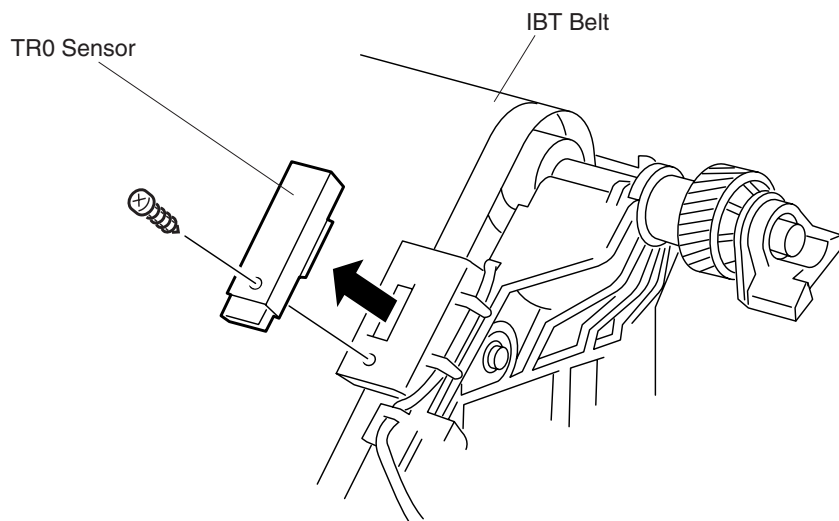
RS1074XC

RRP 9.79 TR0 Sensor (PL8.2.12)

1. Insert the LEDs of the TR0 Sensor through the slot in the IBT frame.
2. Use one screw to secure the TR0 Sensor to the IBT frame.
3. Reconnect the P/J to the TR0 Sensor.
4. Reinstall the Transfer Assembly (RRP 9.71).

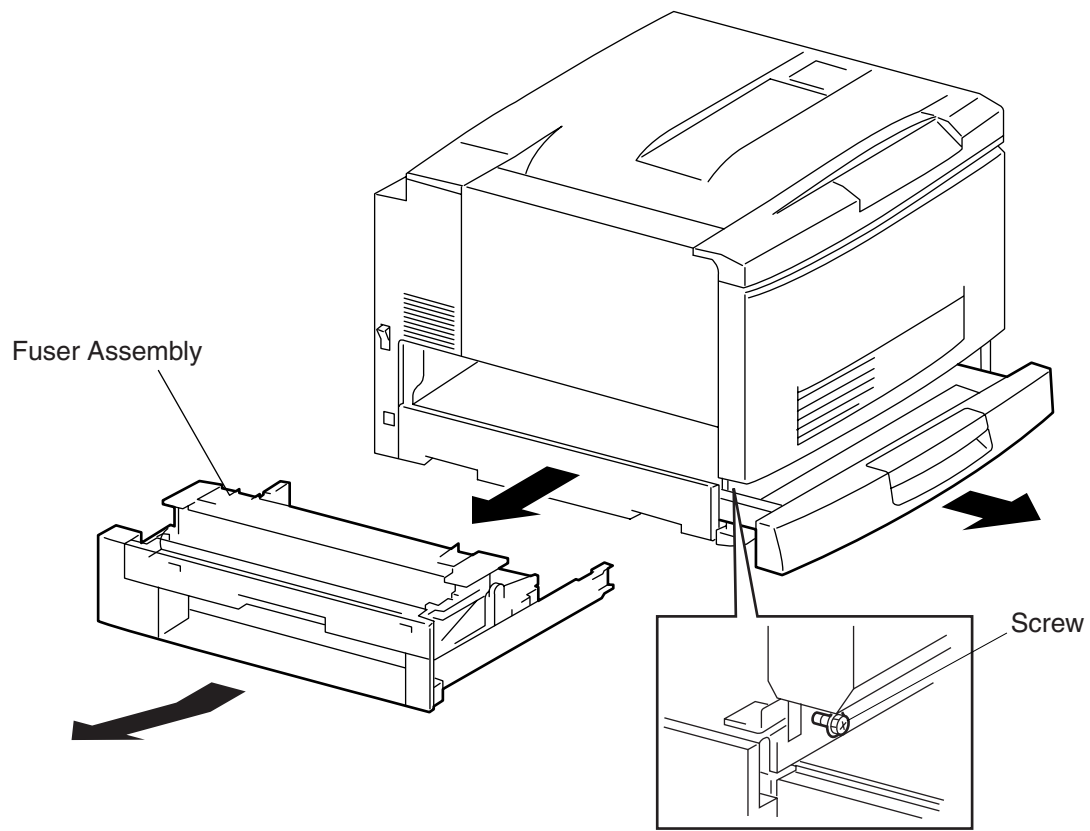
RS1075XC

RRP 9.80 Fuser Assembly (PL9.1.1)

1. Lift the end of the Fuser Assembly as you insert the Assembly side rails into the guide wheels inside the printer.
2. Lower the end of the Fuser Assembly and slide the Assembly into the printer.
3. Slide Tray 1 a few inches out of the printer.
4. Reinstall the screw to secure the Fuser Assembly to the printer frame.

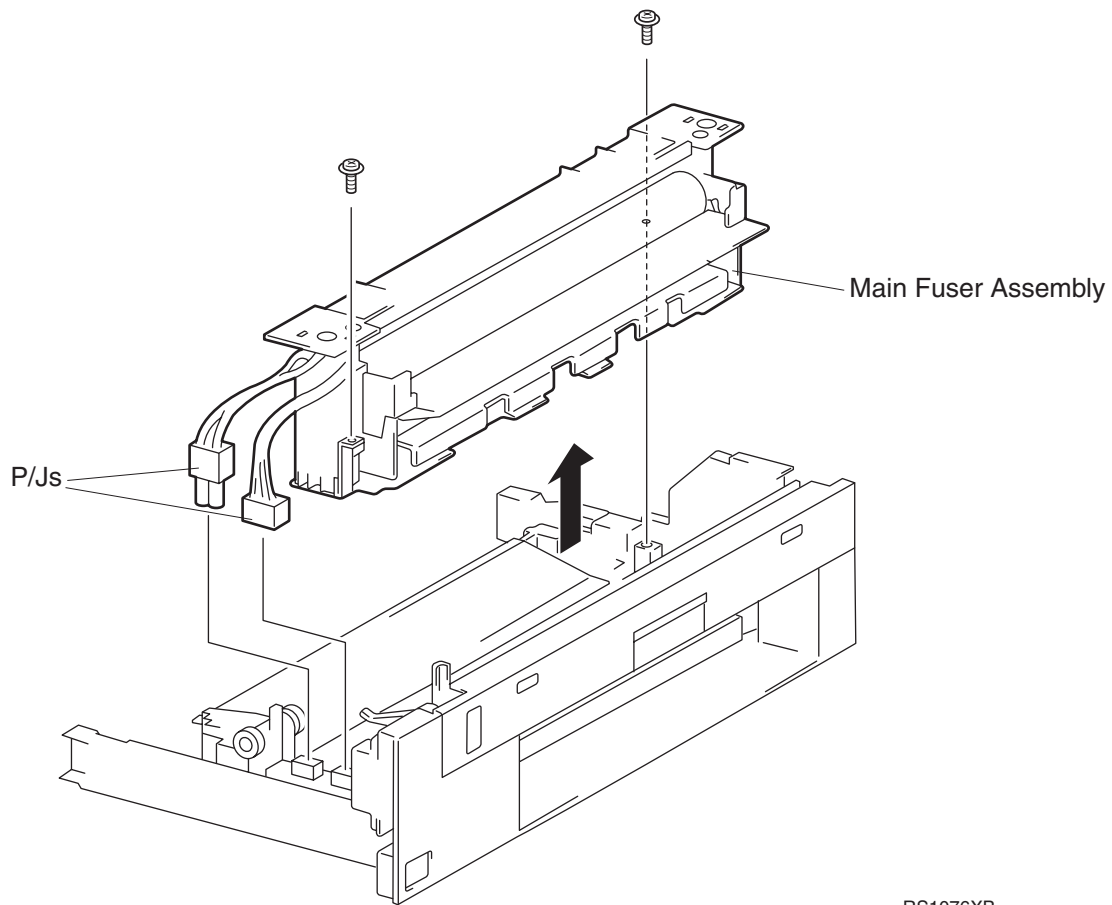
RS1076XB

RRP 9.81 Main Fuser Assembly (PL9.1.2)

1. Lower the Main Fuser Assembly onto the Fuser Tray.
2. User two screws to secure the Main Fuser Assembly to the Fuser Tray.
3. Reconnect the two P/Js that are located at the end of the Main Fuser Assembly.
4. Reinstall the Oil Roll Assembly (RRP 9.82).
5. Refer to Section 9 of this manual and reset to zero the two Life Counters for the Main Fuser Assembly.

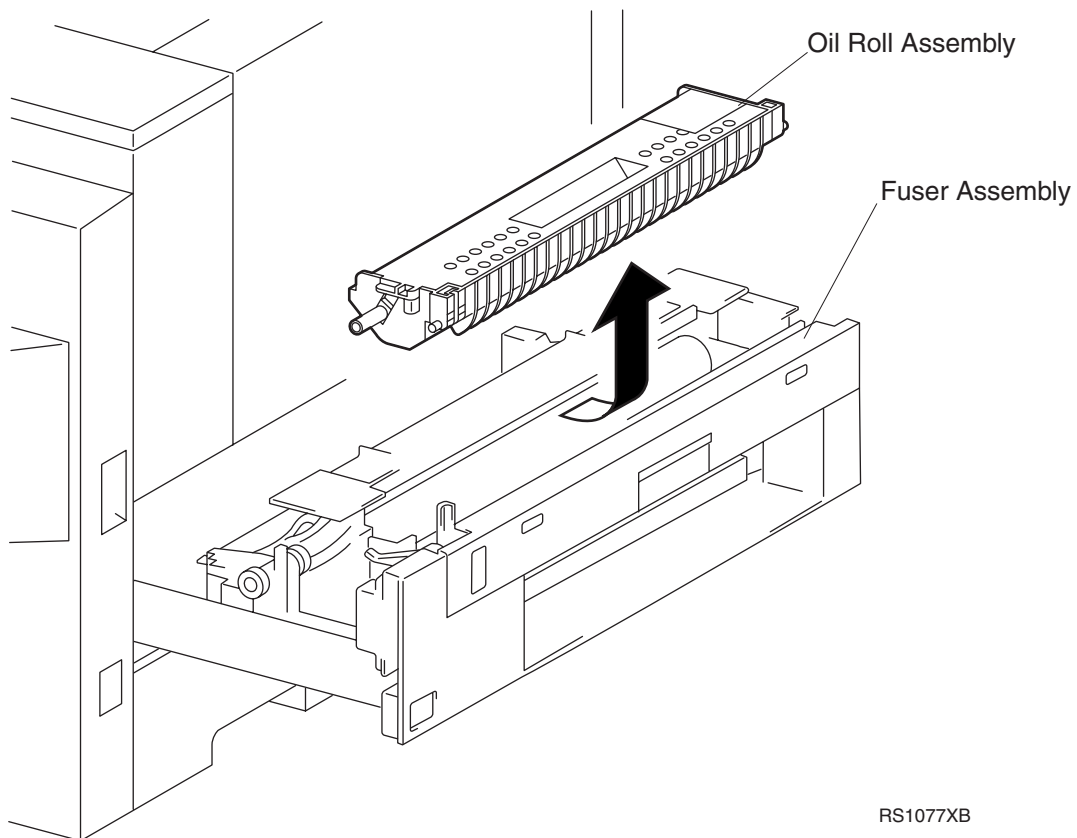
RS1077XB

RRP 9.82 Oil Roll Assembly (PL9.1.10)

1. Slide the Fuser Assembly out of the printer.
2. Hold onto the recessed handle and lower the Oil Roll Assembly into the Fuser Assembly.
3. Press on the Oil Roll Assembly until it snaps into place.
4. Slide the Fuser Assembly into the printer.

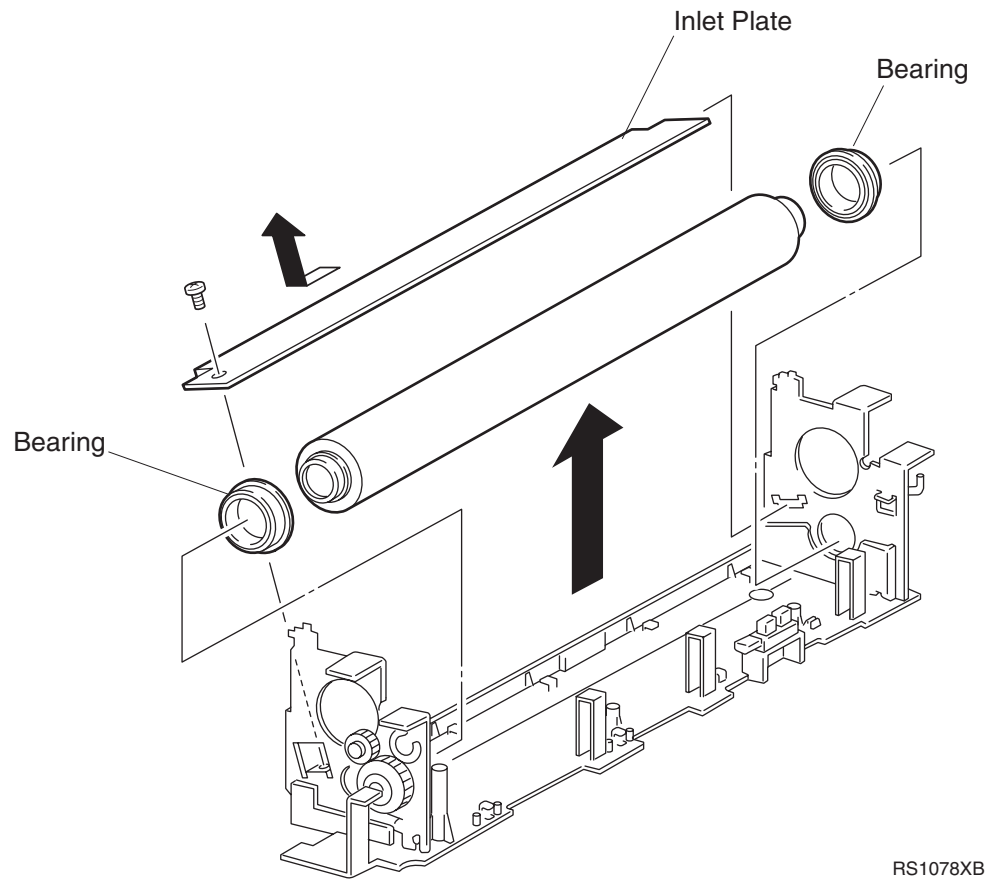
RS1078XB

RRP 9.83 Pressure Roll (PL9.2.9)

1. Remove the Heat Roll Heat Rod (RRP 9.86).
2. Remove the Heat Roll (RRP 9.84).
3. Remove the Lower Guide Assembly (RRP 9.99).
4. Remove the screw securing the Fuser Inlet Plate to the Main Fuser Assembly and remove the Plate.
5. Lift the Pressure Roll front and rear bearings off of the front and rear Fuser Brackets and remove the Pressure Roll.

1. Reinstall the Pressure onto the Main Fuser Assembly so the front and rear bearings rest on the front and rear Fuser Brackets.
The bearing rings should rest on the inside of the Fuser Brackets.
2. Reinstall the Fuser Inlet Plate to the Main Fuser Assembly and use one screw to secure the Plate to the Assembly.
3. Reinstall the Lower Guide Assembly (RRP 9.99).
4. Reinstall the Heat Roll (RRP 9.84).
5. Reinstall the Heat Roll Heat Rod (RRP 9.86).

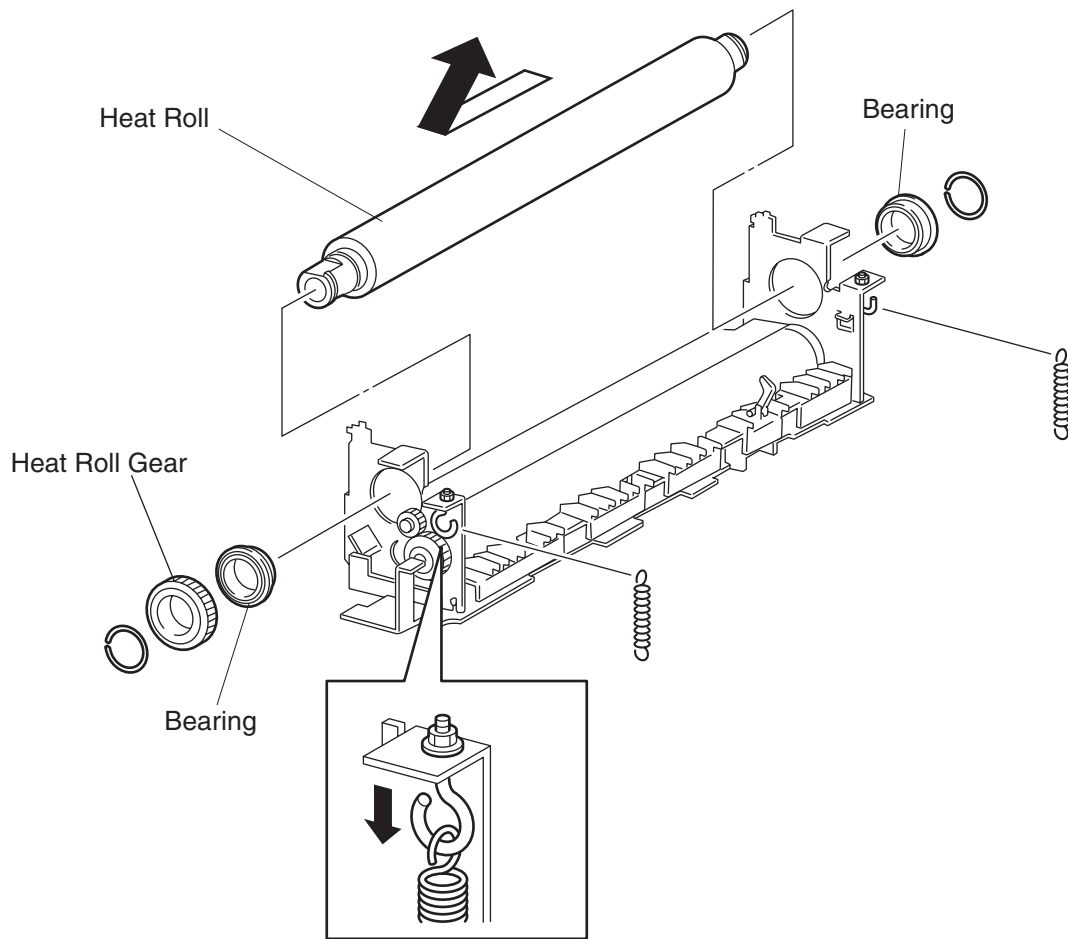
RS1079XB

RRP 9.84 Heat Roll (PL9.2.12)

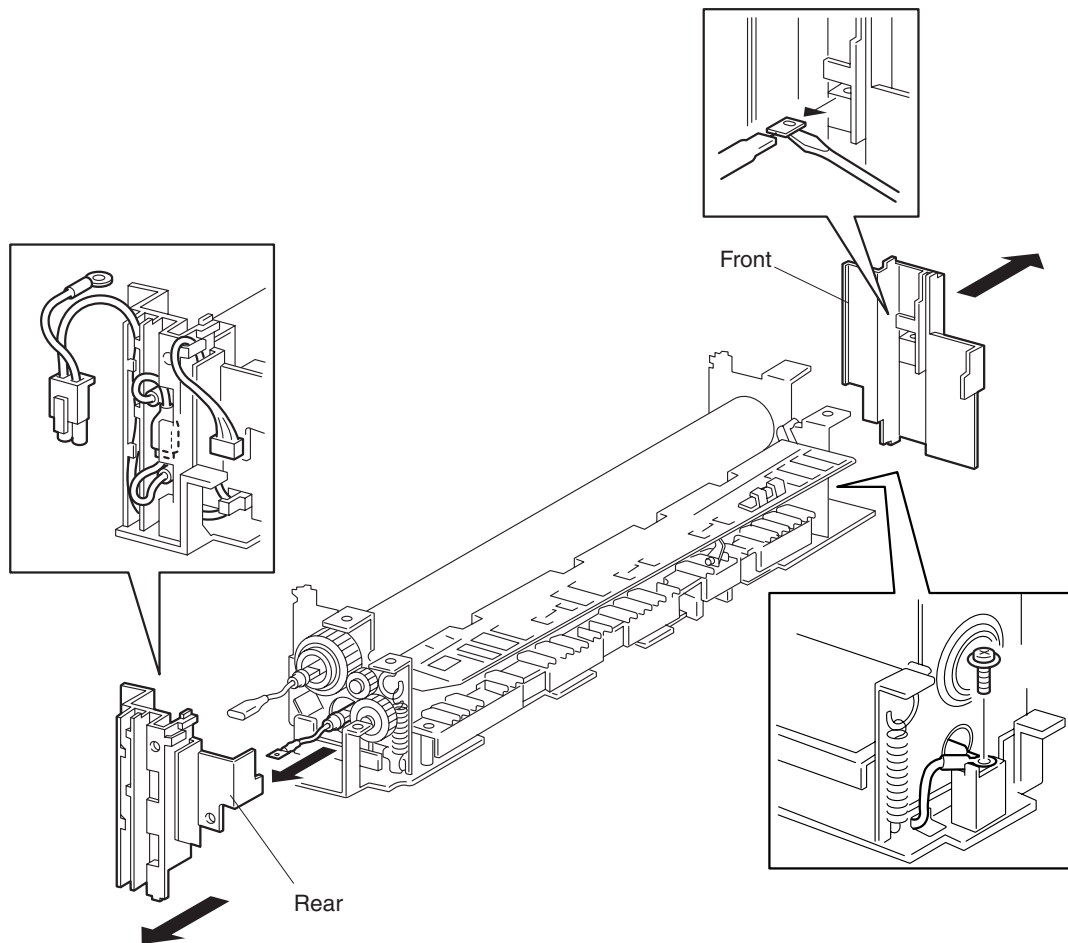
RS1080XB

RRP 9.85 Pressure Roll Heat Rod (PL9.2.19)

1. Carefully insert the flat end of the Heat Rod into the rear of the Pressure Roll and push the Rod until the flat end exits the front of the Pressure Roll
2. Insert the rear of the Pressure Roll Heat Rod and the rear of the Heat Roll Heat Rod through the cut-outs in the Rear Fuser Cover.
3. Reconnect the Pressure Roll Heat Rod to the Heat Roll Heat Rod.
4. Reinstall a new piece of shrink tubing over the connection.
5. Reinstall the Upper Fuser Assembly (RRP 9.87).

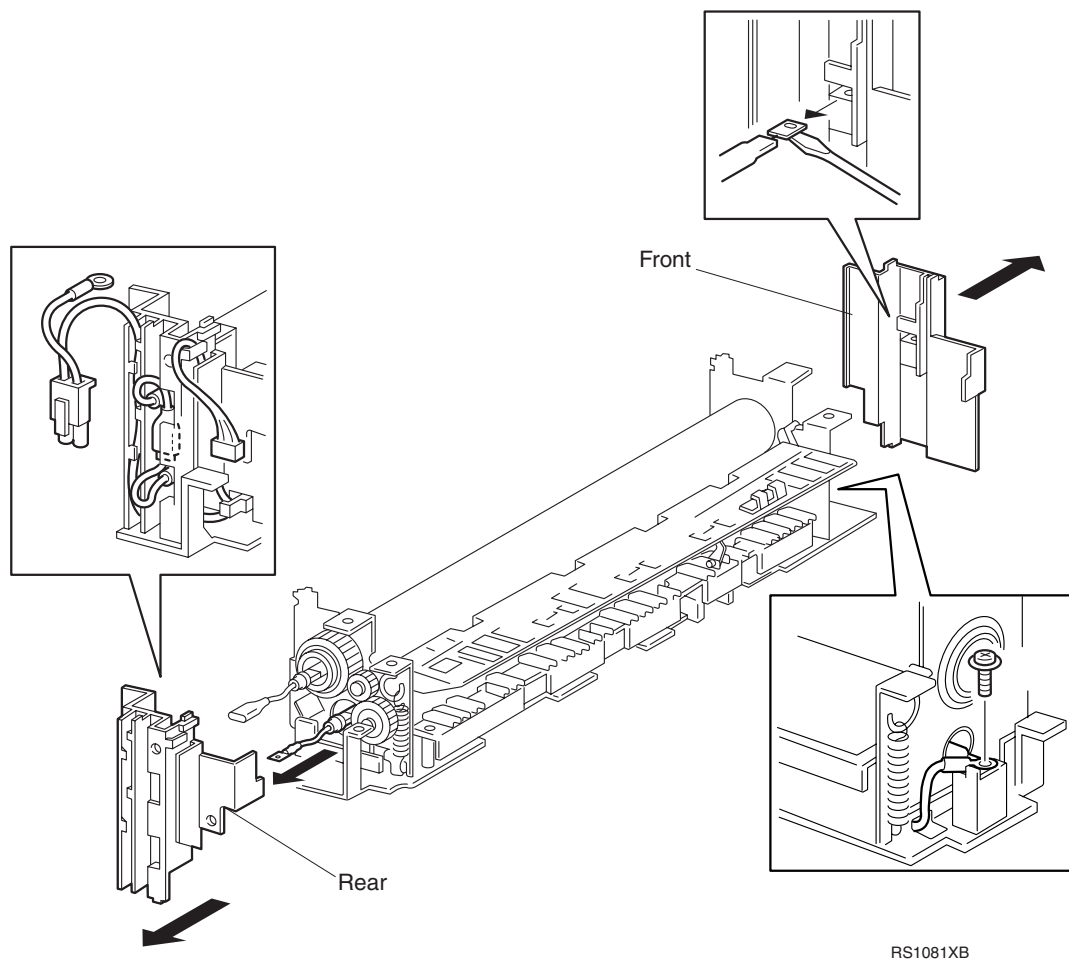
RS1081XB

RRP 9.86 Heat Roll Heat Rod (PL9.2.20)

1. Carefully insert the flat end of the Heat Rod into the rear of the Heat Roll and push the Rod until the flat end exits the front of the Heat Roll
2. Use one screw to connect the front of the Heat Roll Heat Rod to the front of the Main Fuser Assembly.
3. Insert the rear of the Heat Roll Heat Rod and the rear of the Pressure Roll Heat Rod through the cut-outs in the Rear Fuser Cover.
4. Reconnect the Heat Roll Heat Rod to the Pressure Roll Heat Rod.
5. Reinstall a new piece of shrink tubing over the connection.
6. Reinstall the Upper Fuser Assembly (RRP 9.87).

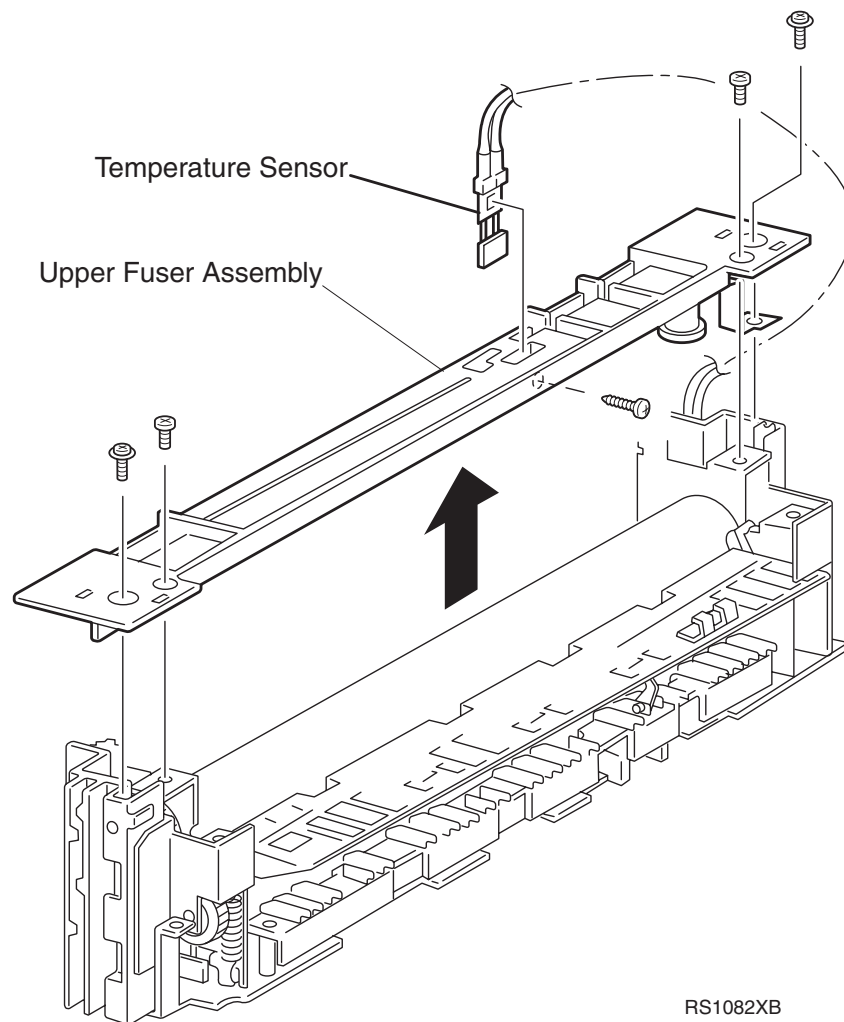
RS1082XB

RRP 9.87 Upper Fuser Assembly (PL9.2.23)

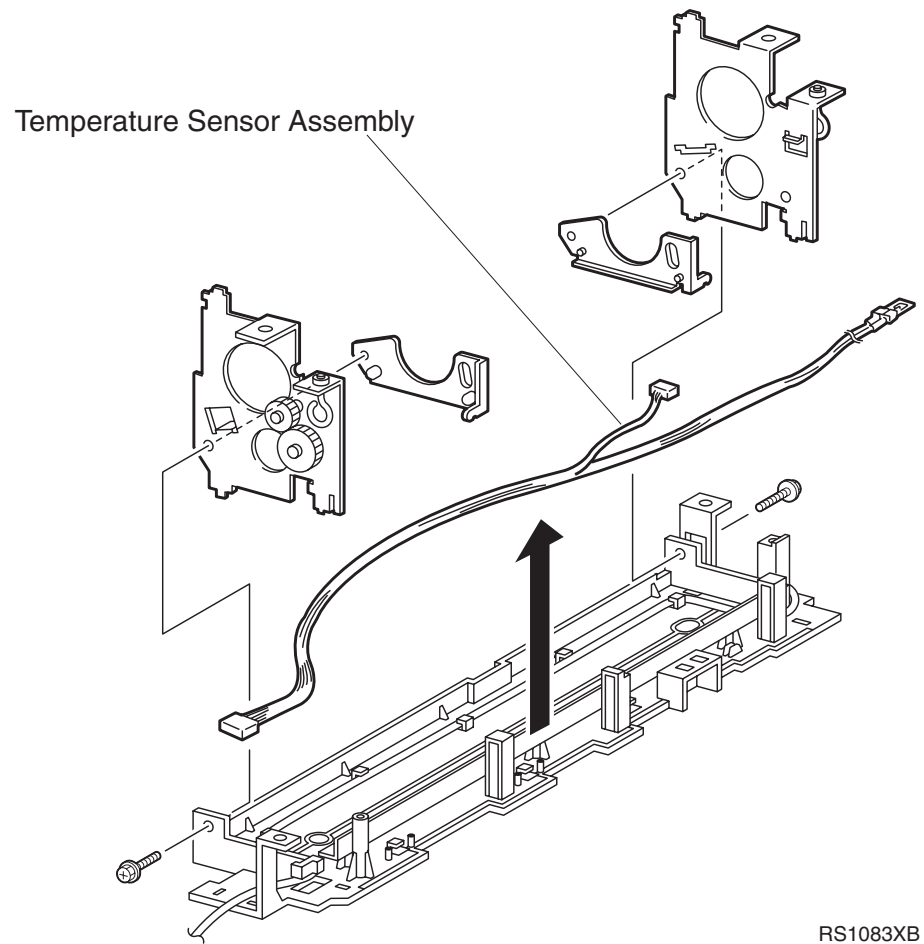
RS1083XB

RRP 9.88 Temperature Sensor Assembly (PL9.2.24)

1. Insert the Temperature Sensor through the opening in the top of the Upper Fuser Assembly.
2. Position the Sensor so the sensing head faces up.
3. Align the screw hole and positioning tab on the Sensor with the screw hole and positioning hole on the Upper Fuser Assembly.
4. Use one screw to secure the Temperature Sensor to the Upper Fuser Assembly.
5. Route the wire harness along the top of the Upper Fuser Assembly, down the side of the Front Fuser Cover, across the Fuser Bottom Plate, under the Rear Fuser Cover, and out the Rear of the Upper Fuser Assembly.
6. Reconnect P/J 75 to the Fuser Exit Sensor.
7. Secure the wire harness under all of the harness clips that are molded into the Upper Fuser Assembly.
8. Reinstall the Upper Fuser Assembly (RRP 9.87).

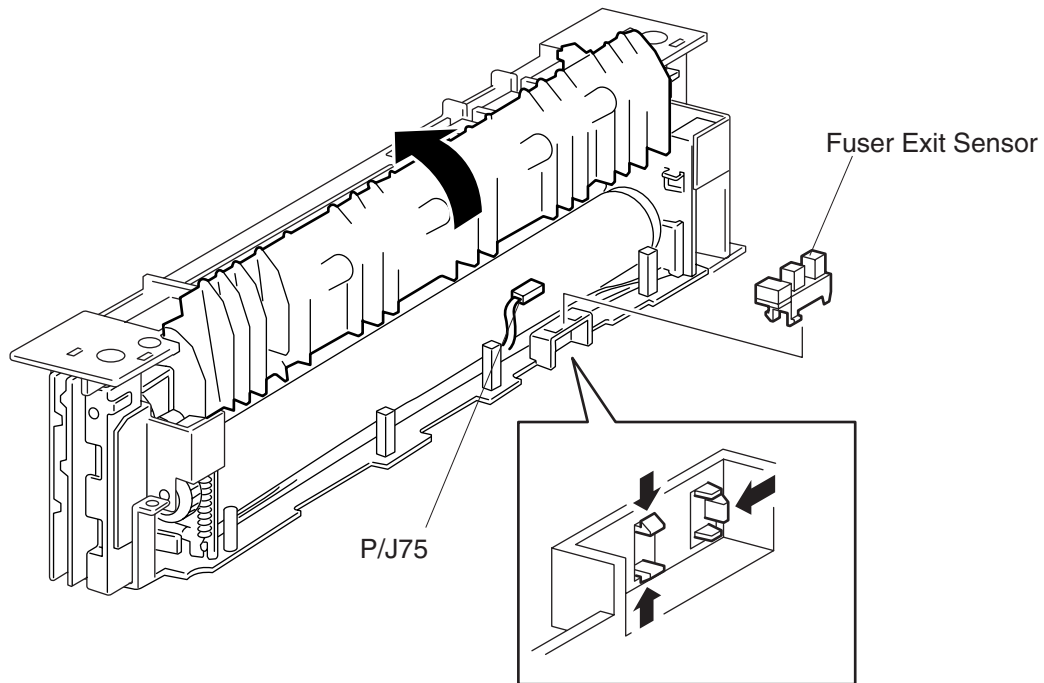
RS1084XB

RRP 9.89 Fuser Exit Sensor (PL9.2.25)

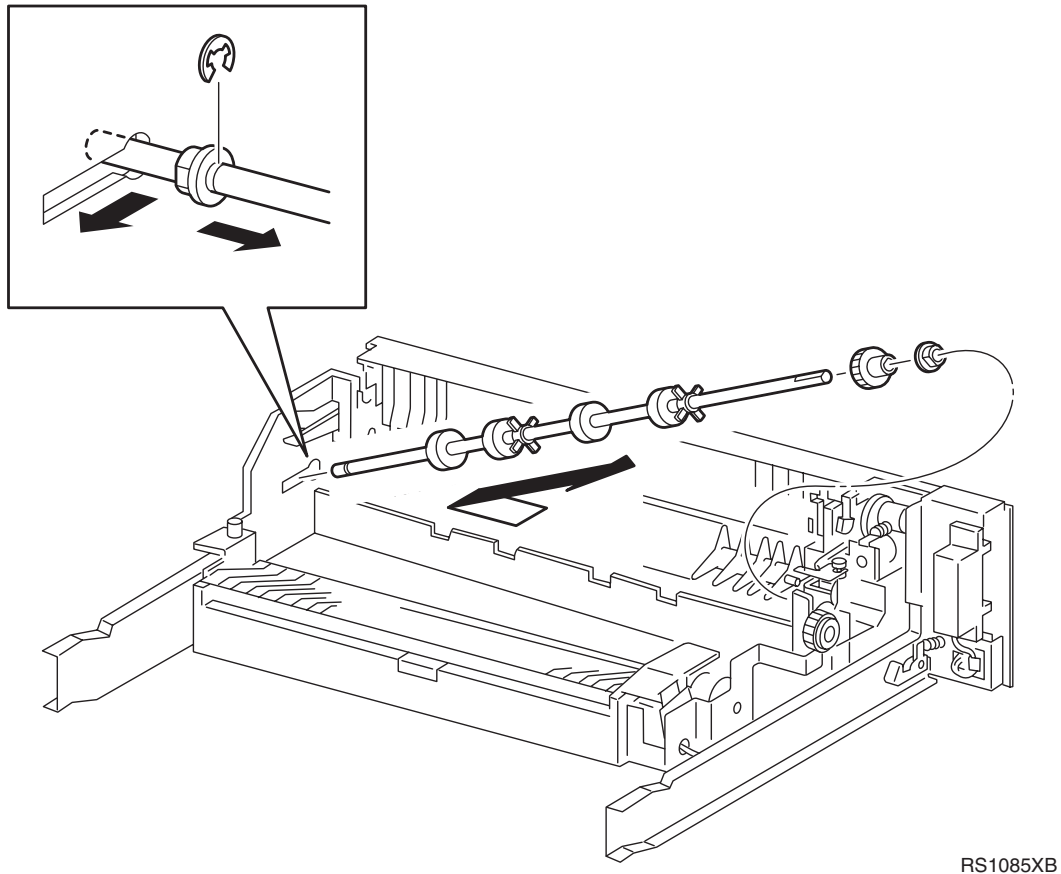
RS1085XB

RRP 9.90 Exit-1 Roll Assembly (PL9.3.7)

1. Make sure the rear bearing is still in place in the cutout at the rear of the Fuser Tray Assembly.
2. Slide the front bearing, with the collar facing the rubber rollers, over the front of the Exit-1 Roll Assembly Shaft.
3. Slide the Exit-1 Gear, with the large side facing the rubber rollers, over the rear of the Exit-1 Roll Assembly.
4. Position the Shaft so the rubber rollers line up with the cutouts in the Fuser Tray Assembly.
5. Insert the front of the Shaft into the slot in the front of the Fuser Tray Assembly.
6. Insert the rear of the Shaft into the rear bearing.
7. Slide the front of the Shaft toward the front bearing cutout in the Fuser Tray Assembly.
8. Slide the front bearing into place in the cutout and use an E ring to secure the Exit-1 Roll Shaft to the front bearing.
9. Reinstall the Main Fuser Assembly (RRP 9.81).

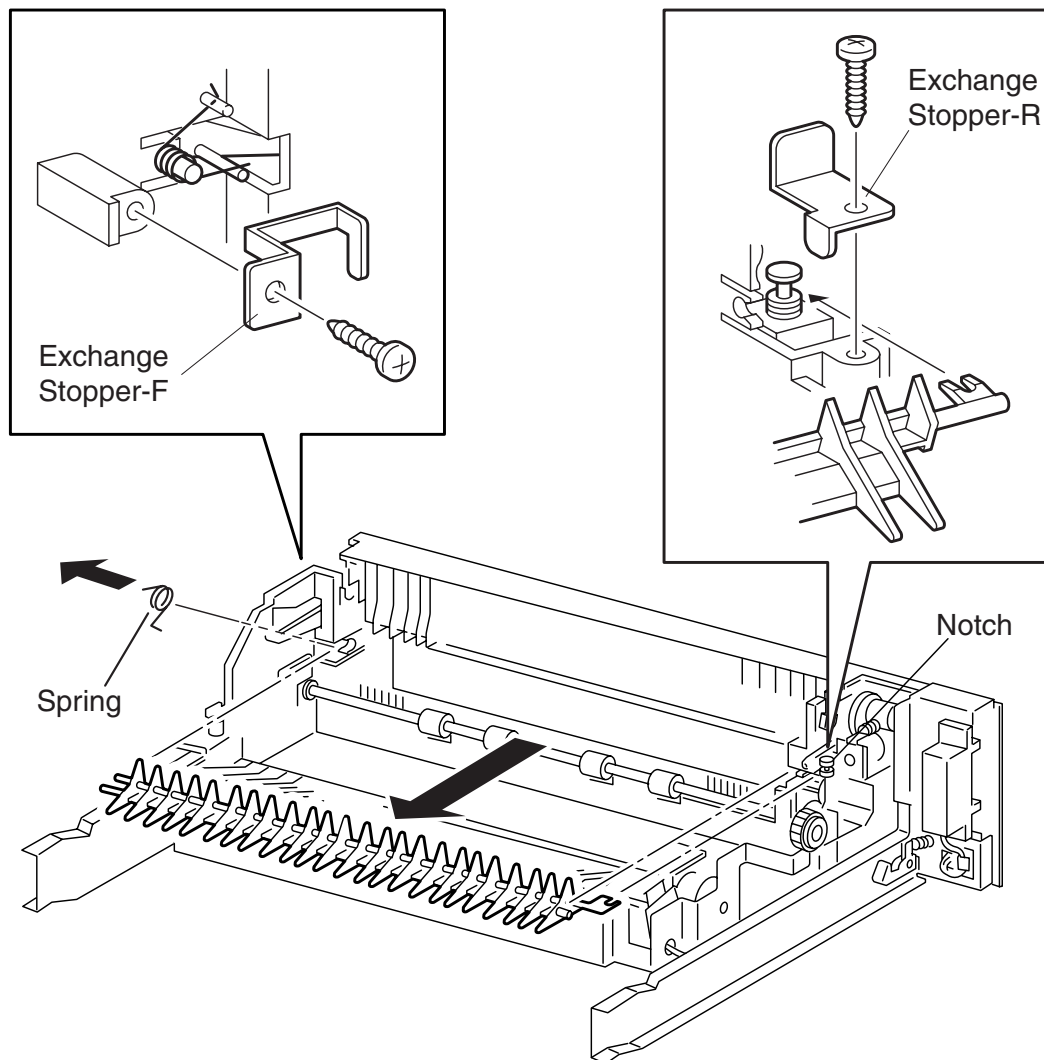
RS1086XC

RRP 9.91 Exchange Chute (PL9.3.10)

1. Insert the front of the Exchange Chute, the straight end, into the notch in the front of the Fuser Tray.
2. Insert the rear of the Exchange Chute, the forked end, into the notch in the rear of the Fuser Tray, making sure the fork engages the Exchange Solenoid plunger.
3. Reinstall the Exchange Spring onto the front end of the Exchange Chute, making sure the straight end of the Spring rests on top of the Chute arm and the hooked end of the Spring is captured by the tab extending from the Fuser Tray.
4. Reinstall the Exchange Stopper-F to the Tray and use one screw to secure the Stopper.
5. Reinstall the Exchange Stopper-R to the Tray and use one screw to secure the Stopper.
6. Reinstall the Main Fuser Assembly (RRP 9.81).

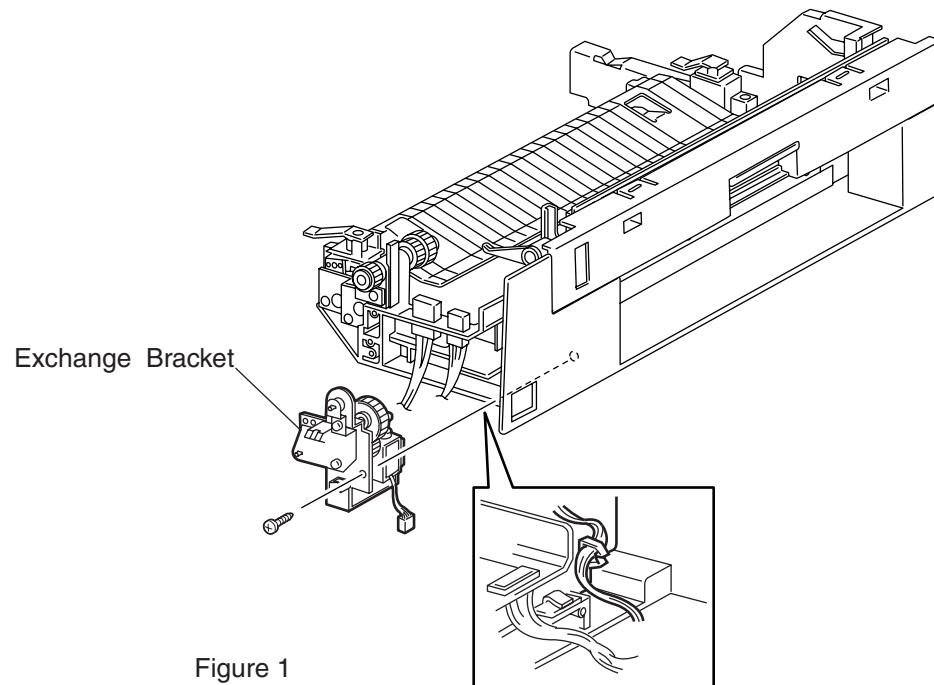
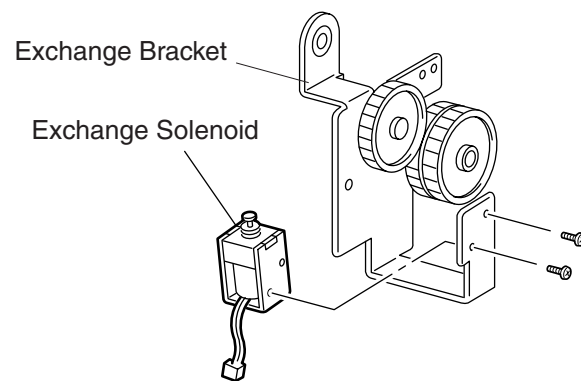
RS1087XB

RRP 9.92 Exchange Solenoid (PL9.3.16)

1. Reinstall the Exchange Solenoid onto the Exchange Bracket.
2. Line up the two screw holes in the Solenoid with the two screw holes in the Bracket.
3. Use two screws to secure the Solenoid to the Bracket.
4. Line up the positioning tab on the Fuser Tray with the positioning hole in the Exchange Bracket and reinstall the Bracket the Tray.
5. Reposition the Bracket as necessary to make sure the Oil Cam Assembly shaft fits through the hole in the Bracket and the Idler Gear shaft fits into the hole in the Fuser Tray.
6. Use two screws to secure the Exchange Bracket to the Fuser Tray.
7. Reinstall the Exchange Chute (RRP 9.91).
8. Reinstall the Oil Cam Solenoid (RRP 9.93).

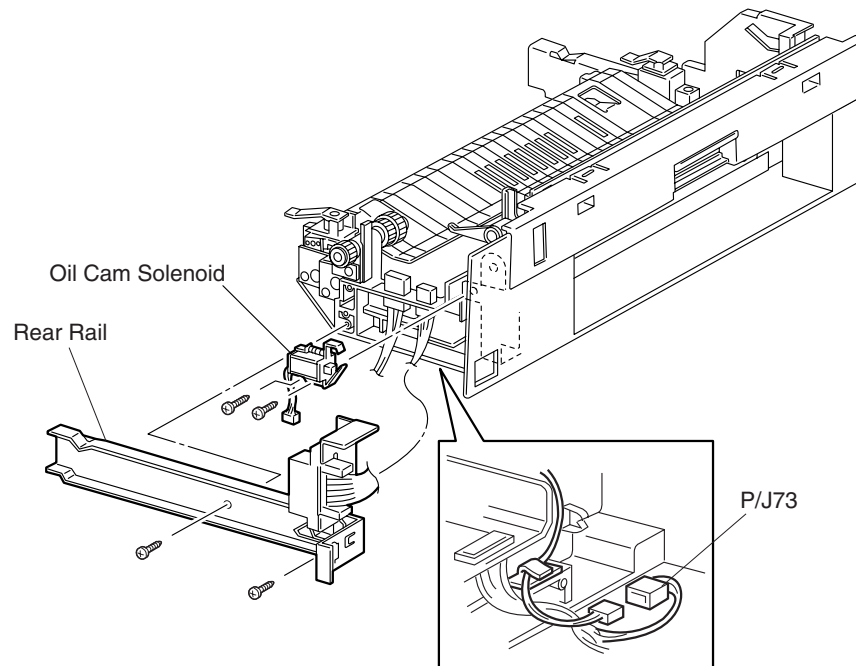
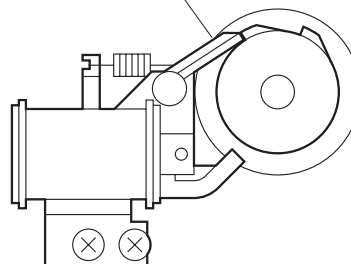
RS1088XB

RRP 9.93 Oil Cam Solenoid (PL9.3.21)

Position of Solenoid arms against Cam

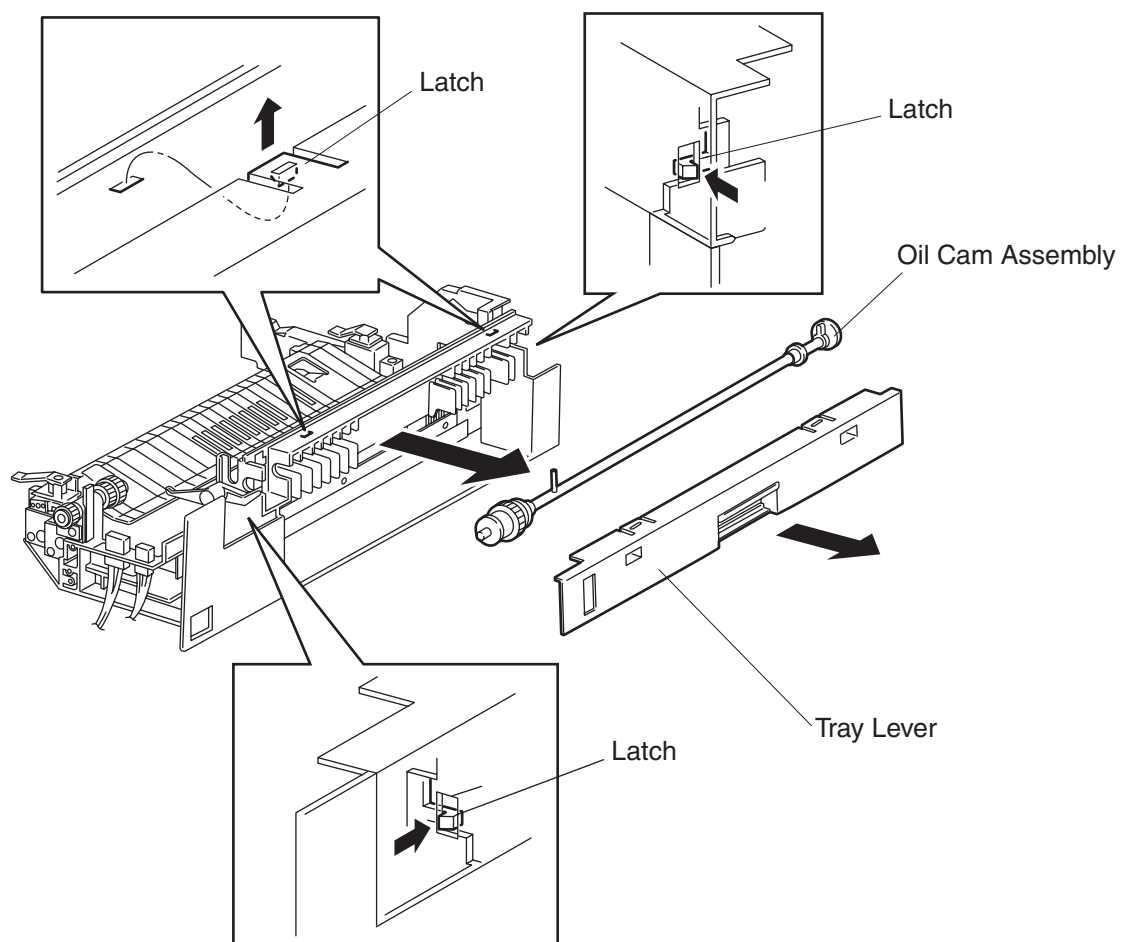
RRP 9.94 Oil Cam Assembly (PL9.3.22)

1. Insert the rear of the Oil Cam Assembly into the hole in the Exchange Bracket.
2. Push down on the Oil Link to move it out of the way as you swing the front end of the Oil Cam Assembly into the channel in the Fuser Tray.
3. When the Oil Cam Solenoid is in place in the channel slide the front and rear bearings into the front and rear bearing notches.
4. Use an E ring to secure the front of the Oil Cam Assembly to the Fuser Tray.
5. Position the Fuser Tray lever so the two latches on the Top of the Lever line up with the two catches on the top of the Fuser Tray.
6. Push the Fuser Lever onto the Fuser Tray.
The four latches snap into place.
7. Reinstall the Oil Cam Solenoid (RRP 9.93).

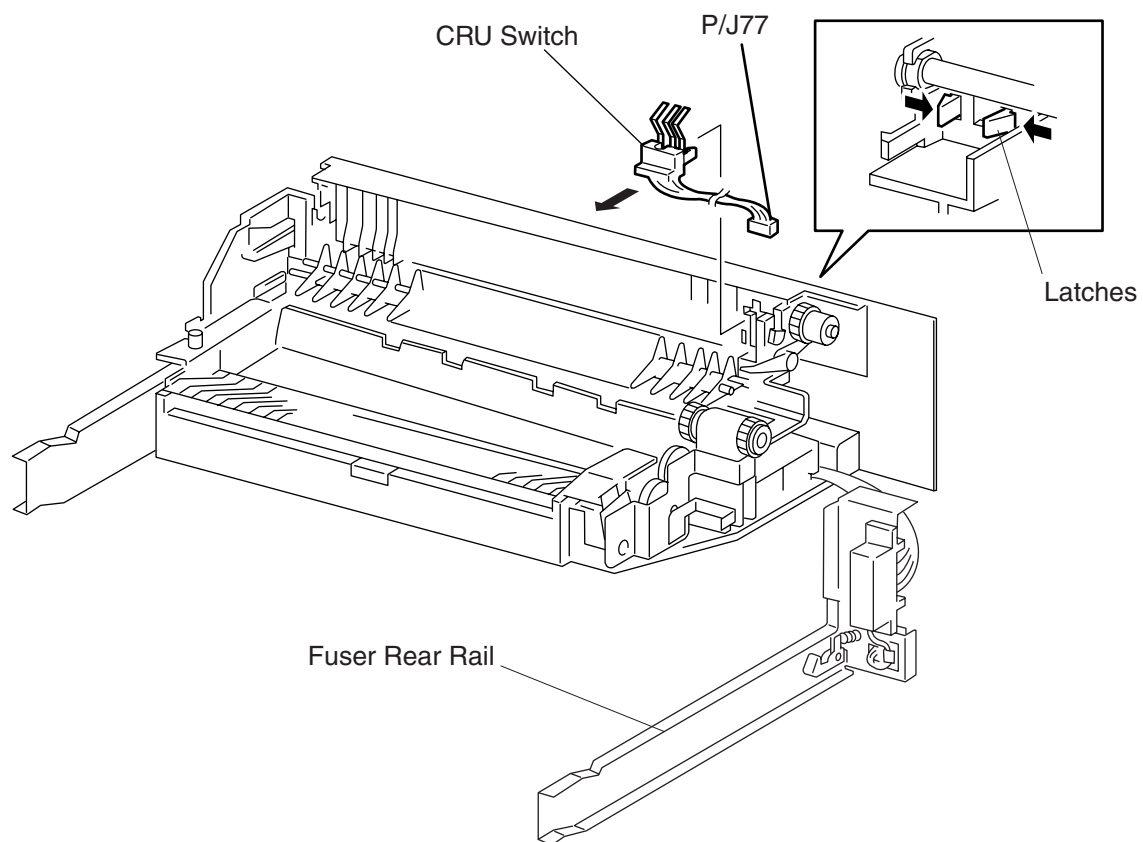
RRP 9.95 CRU Switch Assembly (PL9.3.25)

1. Reinstall the CRU Switch Assembly by first threading the wire harness down the hole in the Fuser frame and out through the rear of the frame.
2. Push the CRU Switch against the Fuser frame until the latches lock the Switch into place.
3. Reconnect P/J77 to the CRU Switch.
4. Reinstall the Fuser Tray Lever.
5. Reinstall the Fuser Rear Rail and use two screws to secure the Rail to the Fuser frame.
6. Position the Fuser Tray lever so the two latches on the Top of the Lever line up with the two catches on the top of the Fuser Tray.
7. Push the Fuser Lever onto the Fuser Tray.
8. The four latches snap into place.
9. Reinstall the Oil Roll Assembly (RRP 9.82).
10. Reinstall the Fuser Assembly (RRP 9.80).

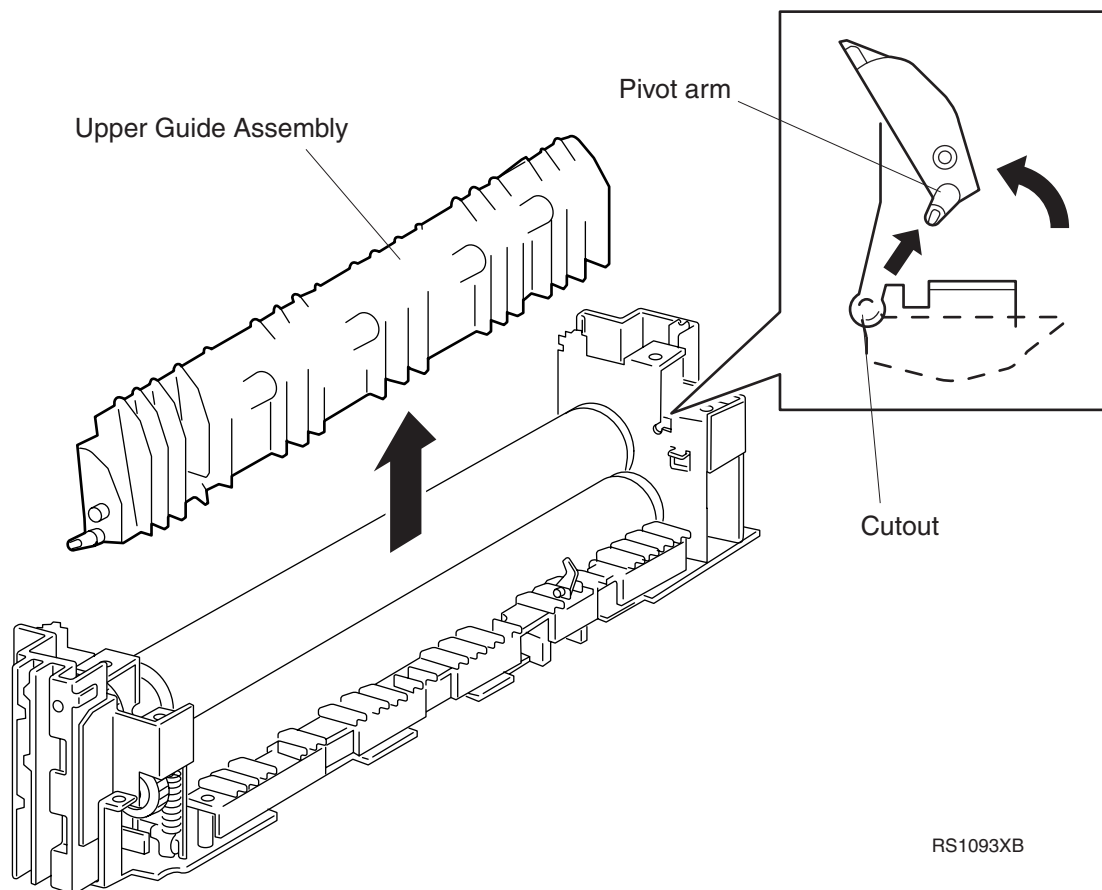
RRP 9.98 Upper Guide Assembly (PL9.2.32)

1. Position the Upper Guide Assembly as shown in the figure and insert the front and rear pivot arms into the cutouts in the Fuser frame.
2. Close the Upper Guide Assembly.
3. Reinstall the Oil Roll Assembly (RRP 9.82).

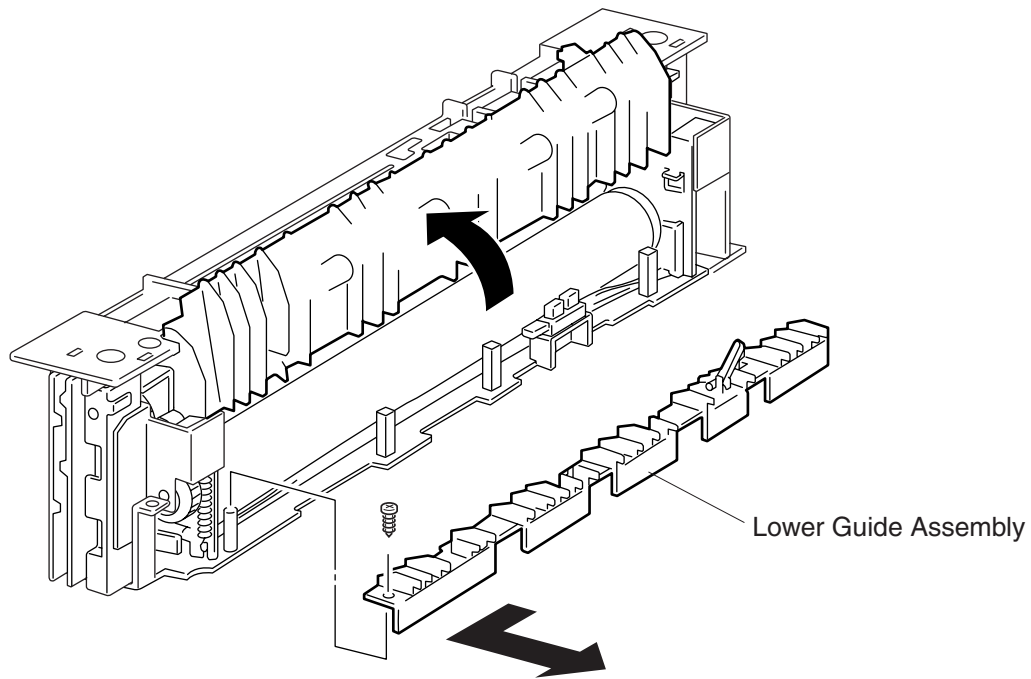
RRP 9.99 Lower Guide Assembly (PL9.2.26)

1. Reinstall the Lower Exit Guide by positioning the Guide slightly to the rear of the installed position and with the Heat Roll Fingers resting on the Heat Roll.
2. Slide the Guide to the front of the Fuser, making sure you hook the three latches that are under the Guide.
3. Line up the screw hole in the Guide with the screw hole in the Fuser frame and use one screw to secure the Guide to the Fuser.
4. Reinstall the Upper Guide Assembly (RRP 9.98).
